CHARACTERIZATION OF MECHANICAL DAMAGE MECHANISMS IN CERAMIC AND POLYMERIC MATRIX COMPOSITE MATERIALS

By
James Lankford, Jr.

TECHNICAL REPORT
ONR Contract No. N00014-92-C-0093
ONR Contract Authority NR 032-553
SwRI Project 06-5035

This report consists of four papers submitted for publication in the journals noted on the title pages. Some of the work represents collaborative effort between researchers at Southwest Research Institute, Michigan Technical University, and the Commission of the European Communities Joint Research Centre, Ispra, Italy.

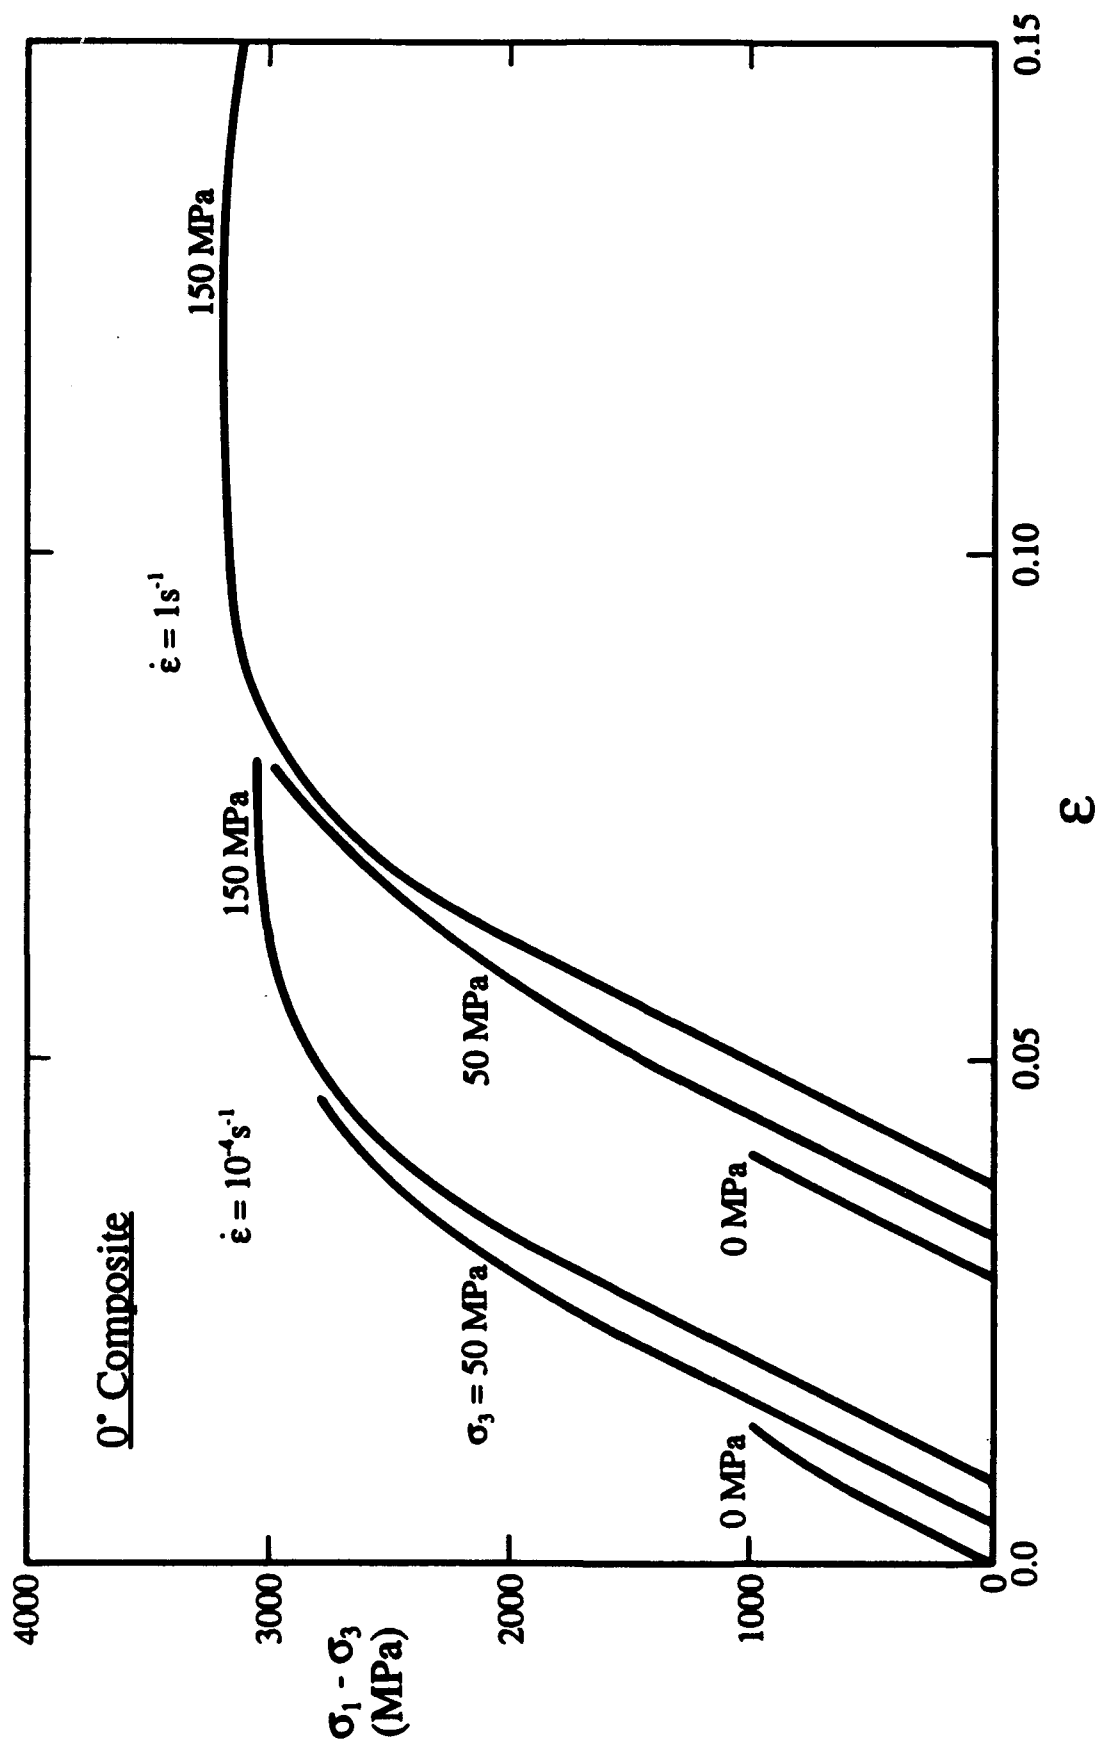
FIGURE 6. Axial stress versus strain for uniaxially reinforced composite.

Uniaxially reinforced pyroceramic "yields" at all strain rates and pressures (Figure 6); "yield" and ultimate strengths again are strain rate independent. However, above some critical value in confining pressure, the ultimate strength becomes virtually insensitive to further increase in confinement.

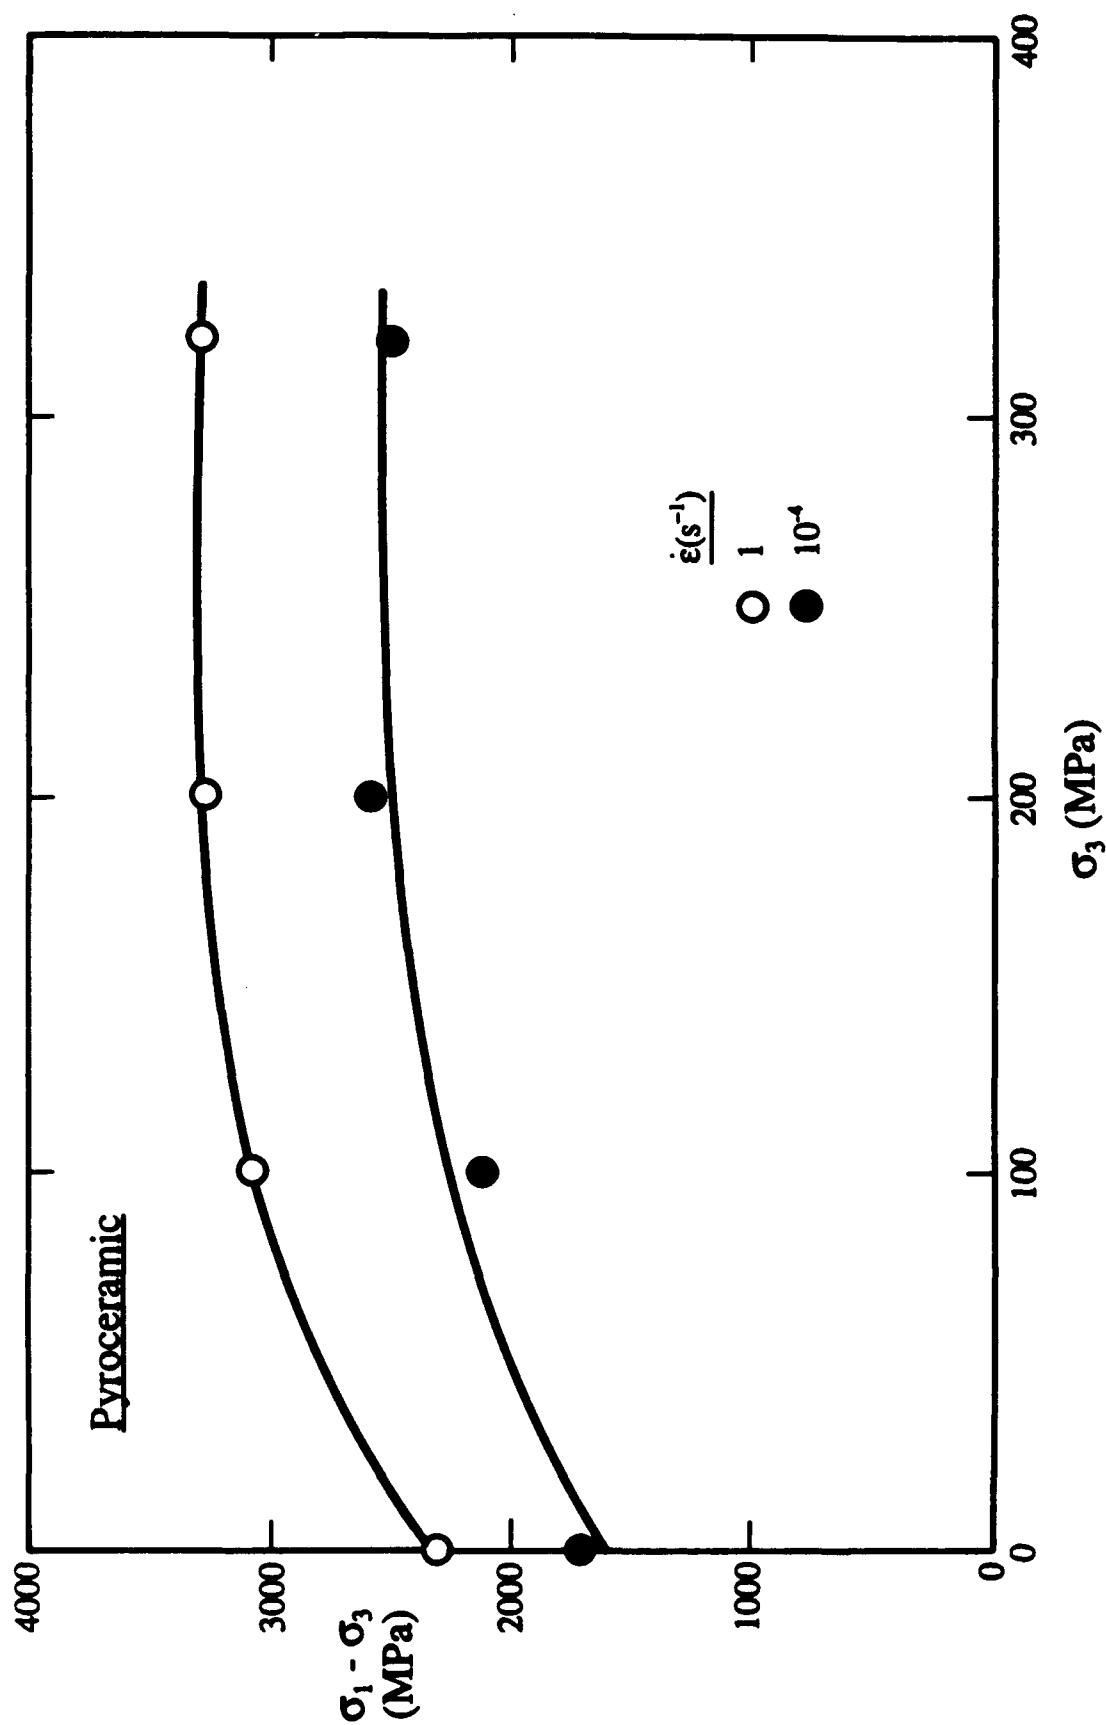
FIGURE 7. Compressive strength of pyroceramic versus confining pressure.

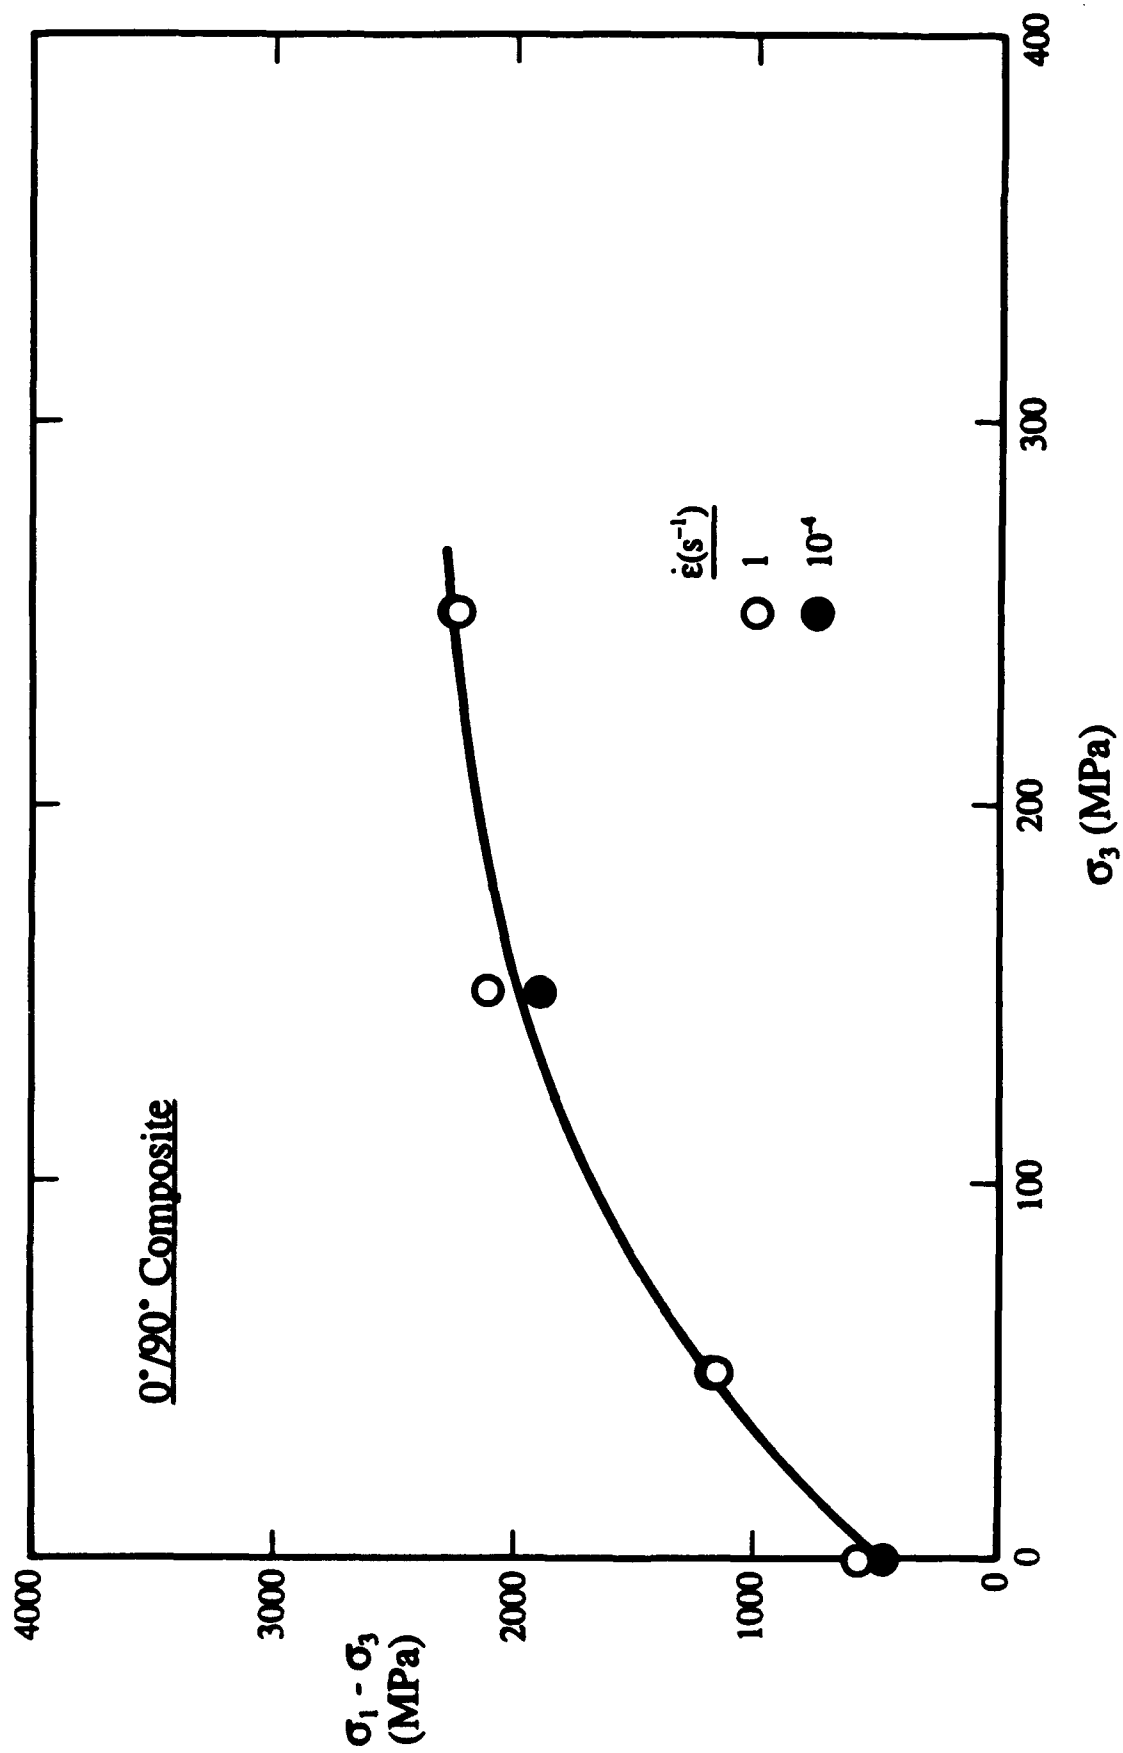
FIGURE 8. Compressive strength of 0°/90° composite versus confining pressure.

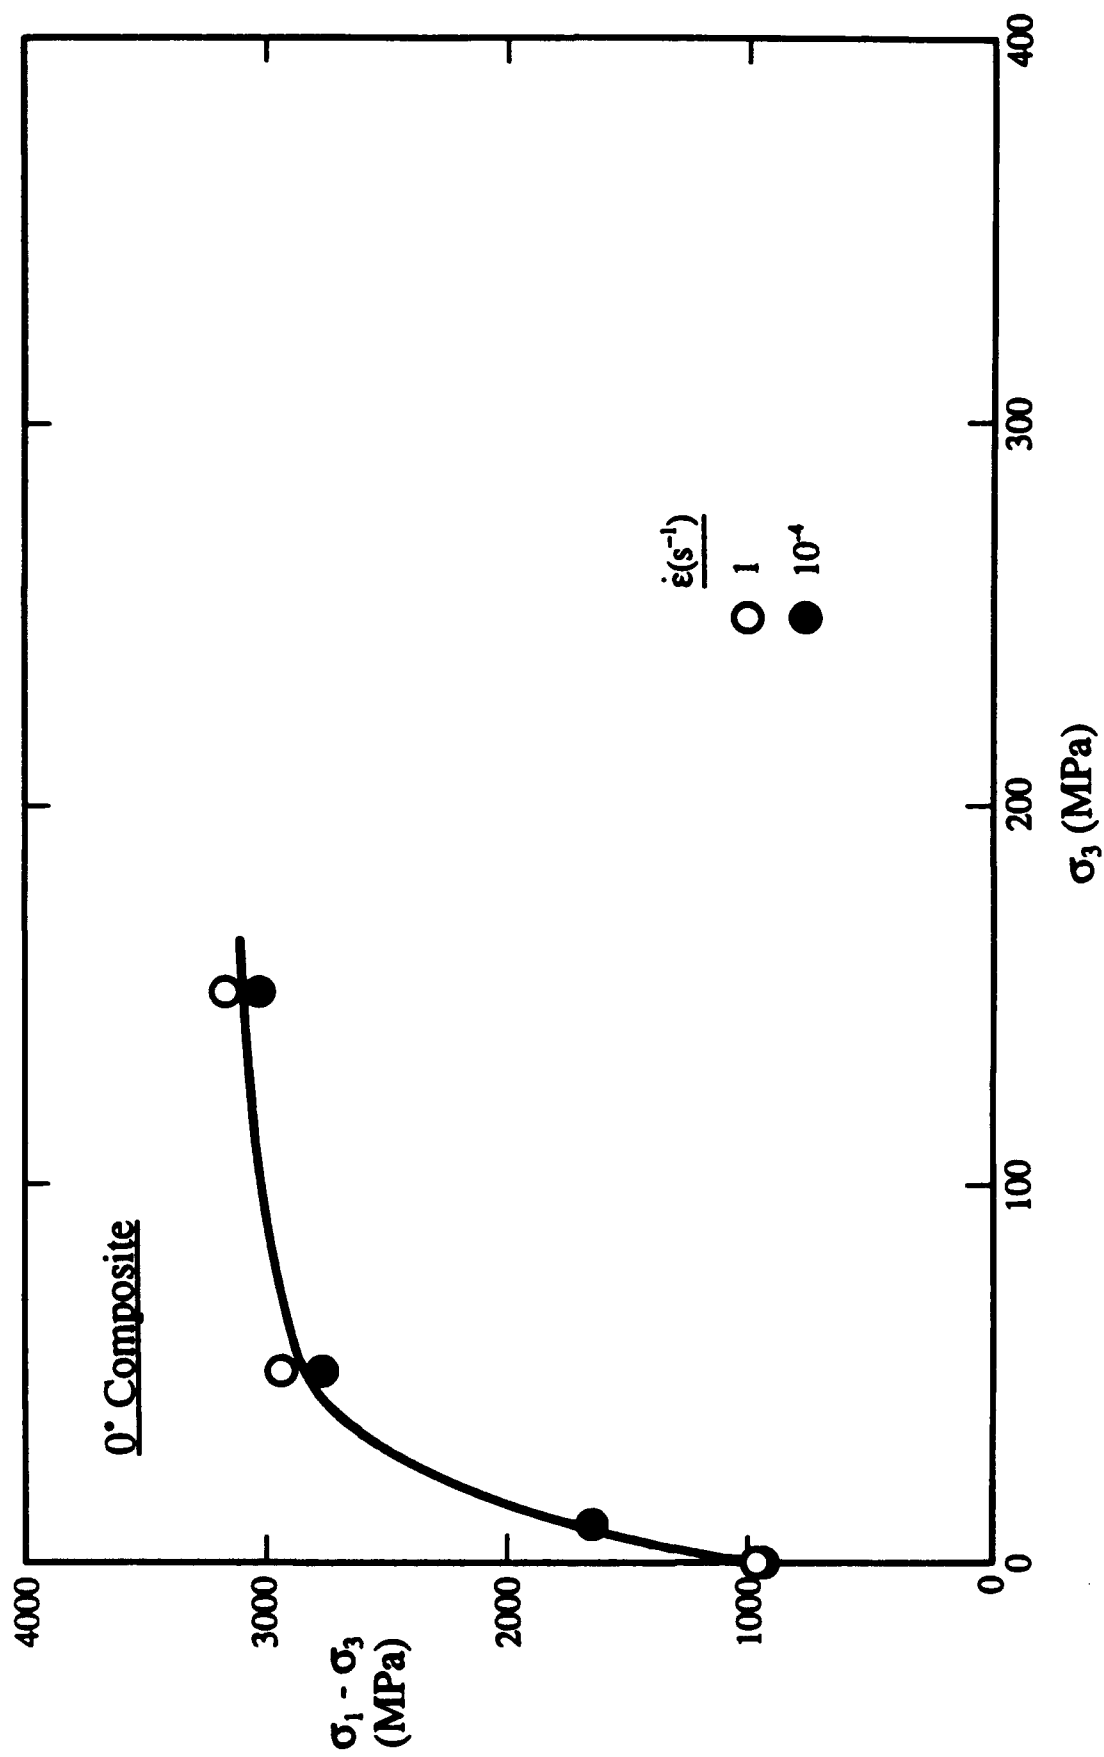
FIGURE 9. Compressive strength of 0° composite versus confining pressure.

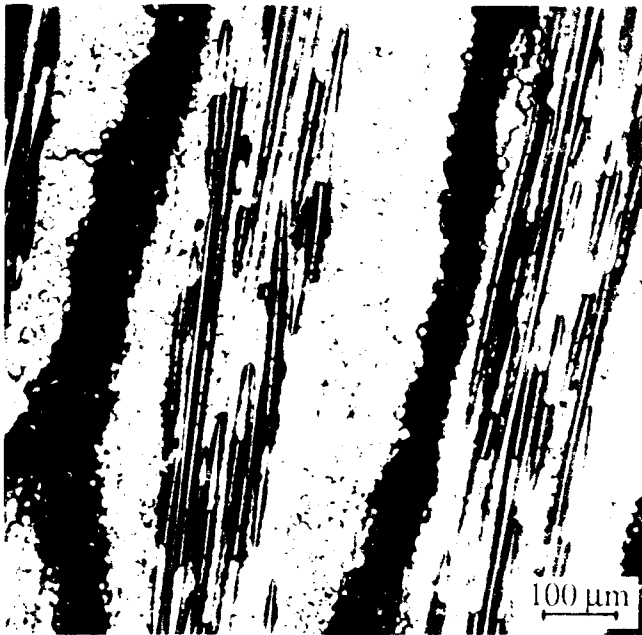
(a) Axial splitting.

(b) Formation of shear fracture zones (arrows) within 90° plies.

(c) Matrix microfracture at site of 0° ply failure.

FIGURE 11. Compressive failure of 0°/90° composite, $\sigma = 10^5 \text{ psi}$, $G = 0.5G_0$ (vertical).

In the case of $0^\circ/90^\circ$ composites, failure initiates with axial cracking between adjacent fibers in 90° plies (Figure 11a); the cracks grow subcritically, link up into shear ensembles (arrows, Figure 11b) and lead to 0° ply flexure. Failure finally is reached as the 0° elements within the plies

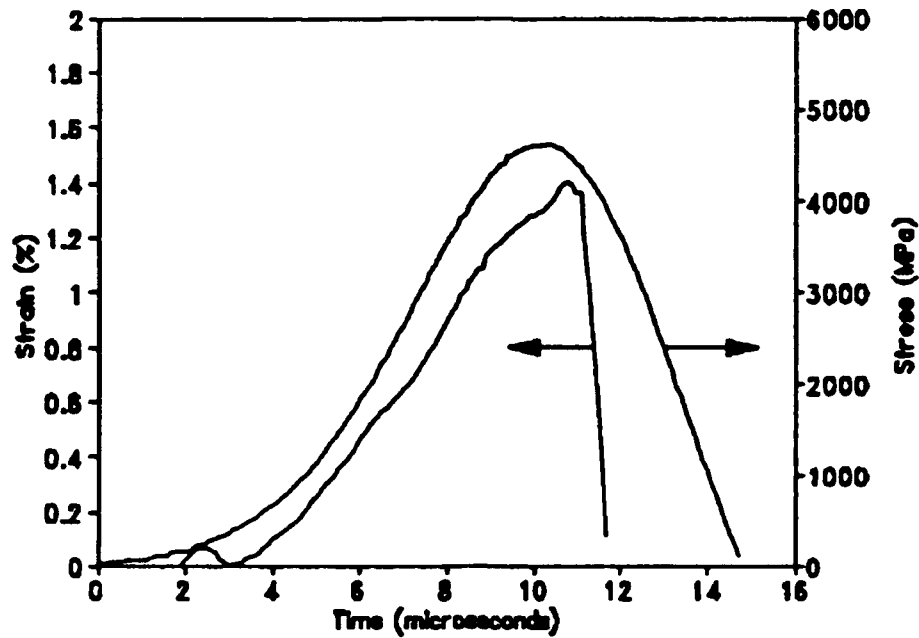
FIGURE 2. Compressive stress and strain signals from SHPB test of MTU alumina. Stress signal was calculated from equation 2 and strain signal came from specimen gage.

based strain rates ($\dot{\epsilon}_g$) of about 2300s^{-1} and 4600s^{-1} , respectively. The difference in strain rates is mainly due to the difference in striker bar velocities; the test shown in Figure 3 had a higher velocity than the one in Figure 2.

If the stresses in Figure 2 are divided by Young's modulus (413 ± 20 GPa, determined from quasistatic and ultrasonic testing), the result is the stress-derived strain signal of Figure 4. The slope of the central portion of this curve gives a stress based strain rate ($\dot{\epsilon}_s$) of 2100s^{-1} , which is within 10% of the strain rate from Figure 2. The strain signal from Figure 2 is repeated in Figure 4 for comparison. The peak stress in the specimen using the specimen gage output and Young's modulus was 4900 MPa, again within 10% of the 4500 MPa indicated by the stress pulse.

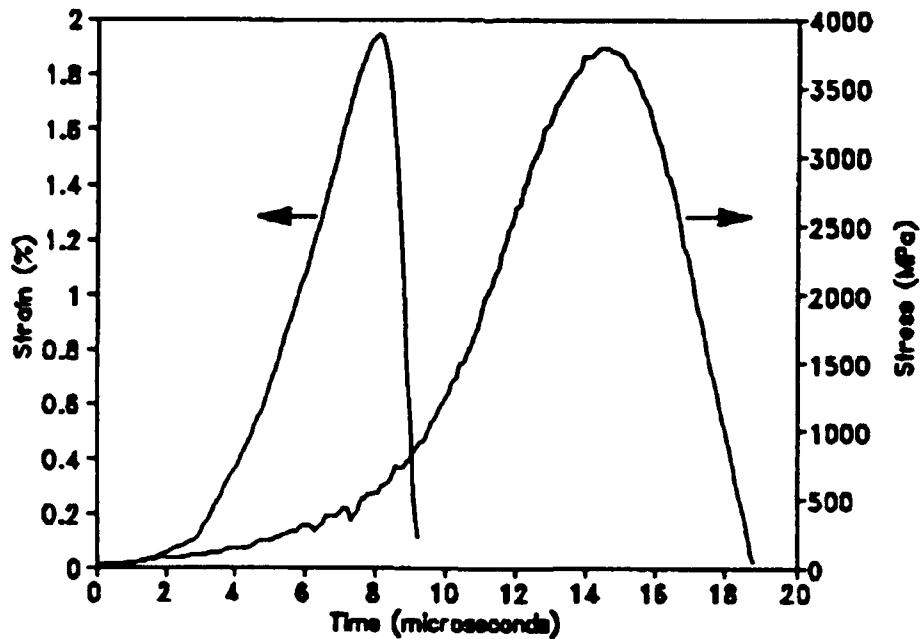
FIGURE 3. Compressive stress and strain signals from SHPB test of MTU alumina. Stress signal was calculated using equation 2 and strain signal came from specimen strain gage.

When a similar analysis was performed on the stress signal of Figure 3, the results were quite different. Noting that the strain signal of Figure 3 peaks in about $7.5\ \mu\text{s}$ compared with $14.5\ \mu\text{s}$ for the stress pulse, this was not surprising. The stress-derived strain signal for this test is shown in Figure 5. This strain signal differs significantly from the specimen strain gage output. The strain gage-derived strain rate of 4600s^{-1} from Figure 3 was significantly higher than the 1800s^{-1} calculated from the stress-derived strain signal of Figure 5. In addition, the peak stress in the specimen using the peak strain of Figure 3 and Young's modulus was about $8000\ \text{MPa}$, over twice the value of $3800\ \text{MPa}$ suggested by the stress pulse in this same figure.

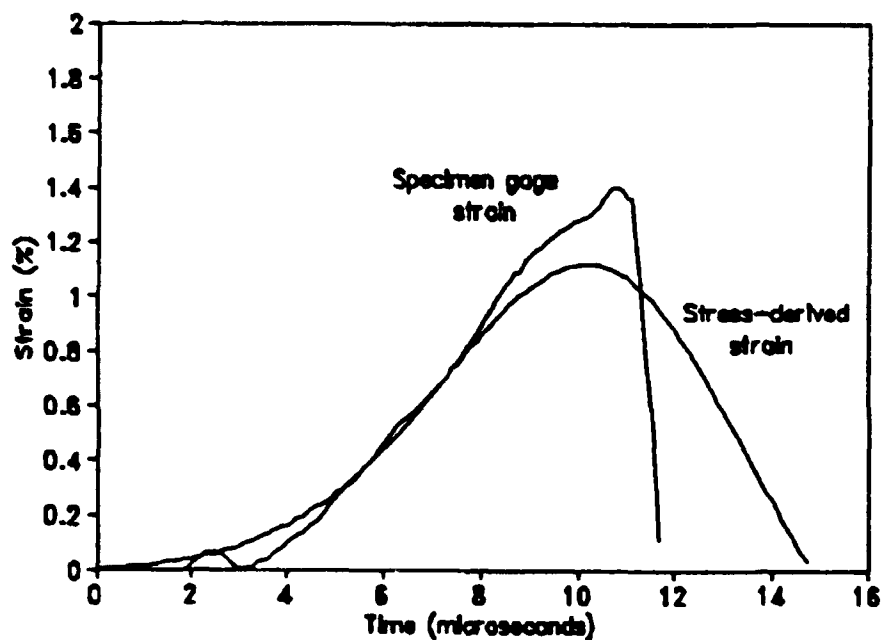
FIGURE 4. Comparison of stress-derived strain and specimen strain gage signal for the low strain rate test of Figure 2.

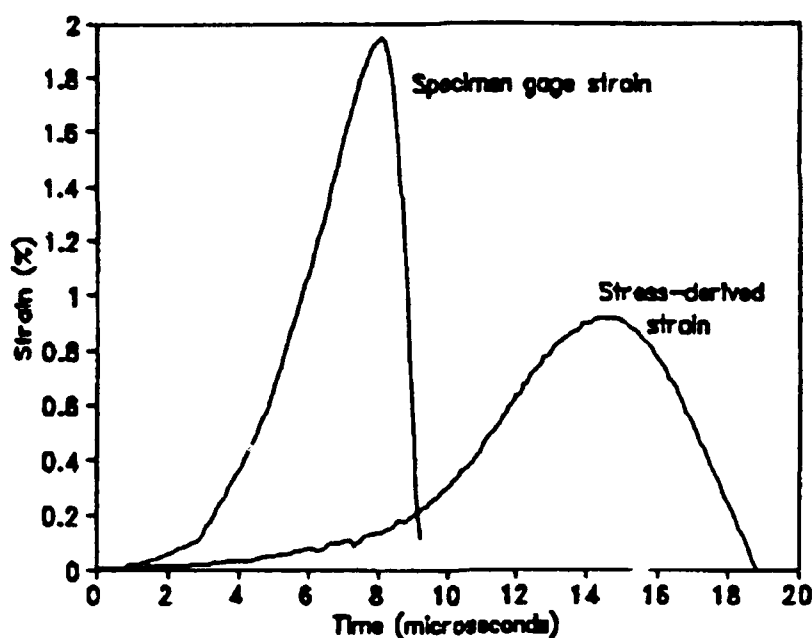
FIGURE 5. Comparison of stress-derived strain and specimen strain gage signal for the high strain rate test of Figure 3.

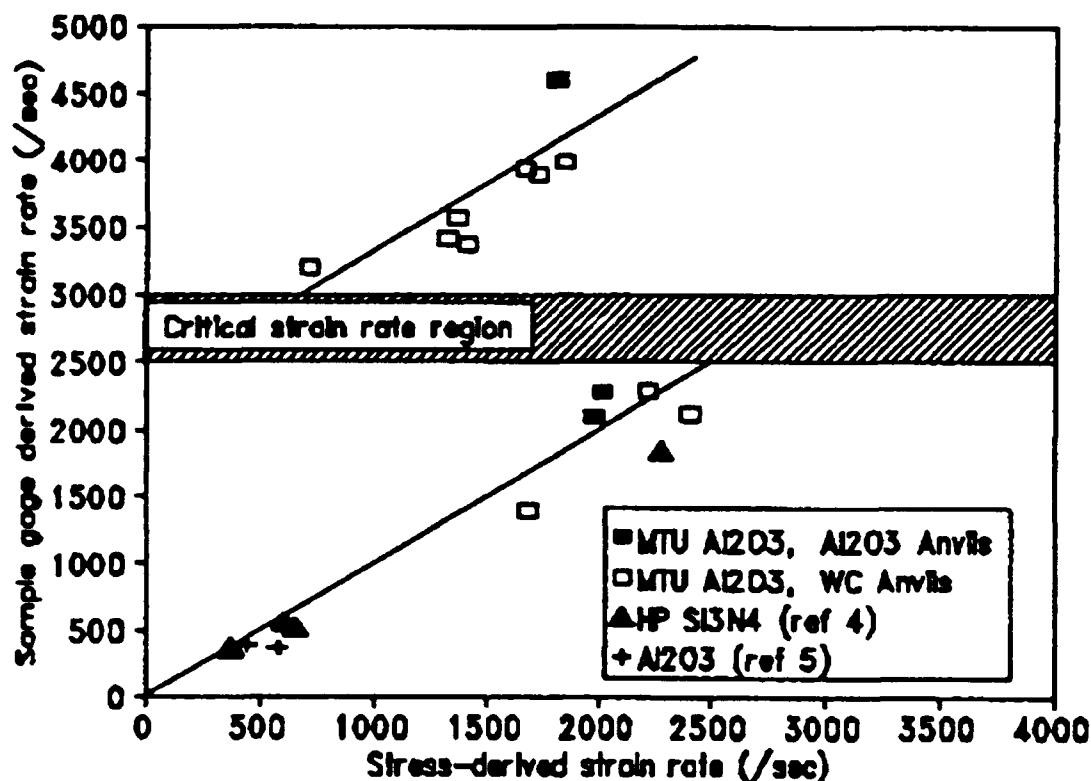
FIGURE 6. Comparison of specimen gage-derived strain rates and stress-derived strain rates for a number of tests.

These results suggest that at the higher strain rates wave dispersion may be compromising the transmitter bar strain gage signal; clearly this would compromise the computed ultimate strength as well. Further evidence for this conclusion is shown in Figure 6.
